## HAVILAND CLUB ASSESSMENT

HSI Project No. 22359

Heritage Standing Inc. (HSI) was engaged by Greg Munn to conduct a conservation-based condition assessment of Haviland Club located on 2 Haviland St., PE. The building is undergoing a restoration and rehabilitation project and protecting the building's historic significance and architectural beauty is a priority.

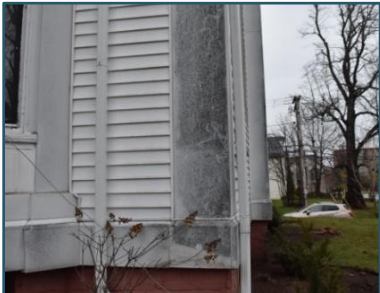
- F. The ramp railing on the north side of the building was trapping debris against the siding (Figure 22).
- G. The siding at the southwest corner had surface staining (Figure 23).

*Figure 23: Surface staining at southwest corner*

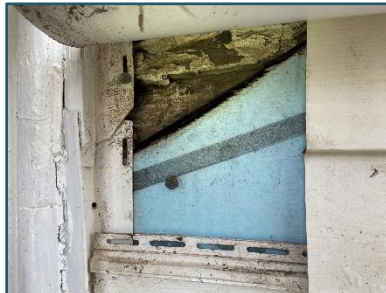
- H. A small portion of vinyl siding was opened on the east wall of the building to investigate wall conditions underneath. The vinyl siding appeared to have been installed on top of wood clapboard siding. The wood clapboard siding was found to be extensively damaged (Figure 24).

*Figure 24: Damaged clapboard siding covered by vinyl siding, photo provided by Greg Munn on 2022-12-20*

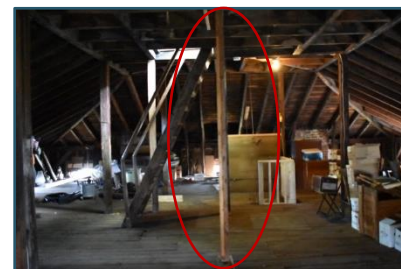
- G. The roof framing members had minor moisture staining (Figure 32).
- H. Three support posts were installed recently (Figure 33). The reason for their installation is unknown. They do not appear to transfer any load to the load bearing walls on the floor beneath.

Figure 33: New support post

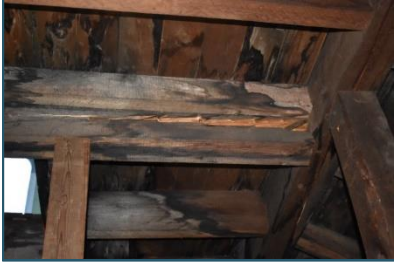
- I. Several structural wood members in the attic were significantly damaged. A major beam running parallel to the entrance into the belvedere had failed and requires urgent action (Figure 34). A major beam running perpendicular to the entrance into the belvedere was failing in torsion (Figure 35). Eight of the posts were splitting and the majority of these were the historic posts (Figure 36). Visual inspection looked for patterns to better understand the damages. Damages that occurred in the past will typically darken with age, so the colour of the openings in a wood member is an initial indication of when the problem may have occurred. Of the significantly damaged members, the cracking revealed bright new wood, which suggests there was recent change to the structure.

*Figure 34: Failed beam*

During the condition assessment, HSI found that two major members in the attic had failed/were failing, and seven to eight of the posts were splitting. The cracking revealed brighter wood underneath that suggests the failure had occurred recently as the exposed wood had not yet darkened with age. The question was raised regarding if cracking was related to tropical storm Hurricane Fiona that brought gale force winds to Charlottetown in September of 2022. Building Managers indicated that Haviland Street was hit particularly bad by the storm, with little protection from the extreme winds. According to a report by the Weather Network, the winds brought by the hurricane reached as high as 135 km/hr.<sup>9</sup> This could have resulted in approximately 40% higher wind loads than the current 1/50-year wind levels the National Building Code requires new construction designs to resist.

Following the site visit further review was undertaken, and results support the initial opinion that Hurricane Fiona was the likely cause of the beam damages. While one of the beams has a more visually significant failure, both urgently require repair. The damage in this region of the attic appears related to an uplift gust.

HSI recommends that immediate action is taken to stabilize the failed structural members in the attic to prevent further loss and risk to safety. The remaining interventions required to address current structural deficiencies can be done practically, with the result to be of greater value than the cost of work.

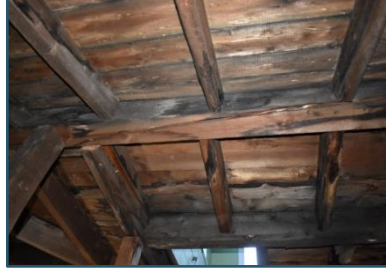
*Figure 35: Failing beam*

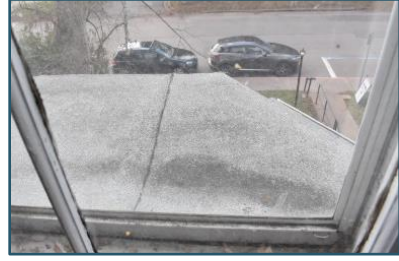
- J. The cellulose insulation seen in the attic, located above the second storey ceiling, appeared to have settled (Figure 37).
- K. The lower roof above the southmost bay window on the west façade has had a history of moisture issues (Figure 38). Upon visual inspection, the roof did not have an adequate slope to divert moisture away from the building (Figure 39). It is further suspected that there are open/worn joints between the roof and vinyl siding where moisture is infiltrating into the building.

*Figure 39: Moisture accumulation on lower roof*

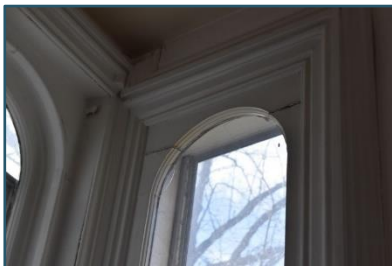
- A. Two windows in the vestibule had an open joint in the framing around the arch (Figure 40).
- B. Plaster cracking was typical throughout the first-floor walls and ceilings (Figure 41, Figure 42, and Figure 43). Vulnerable areas like doorway openings typically had diagonal plaster cracking (Figure 44).

Figure 40: Horizontal cracking in window frame at vestibule

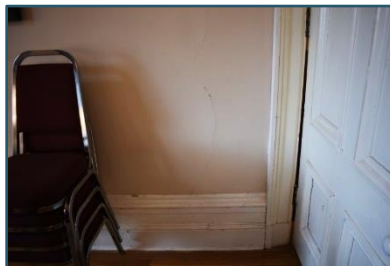
Figure 41: Plaster crack in main room

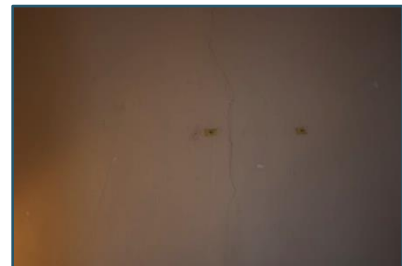
Figure 42: Plaster crack in main room

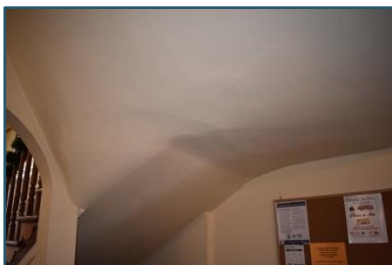
Figure 43: Plaster cracking underneath main staircase

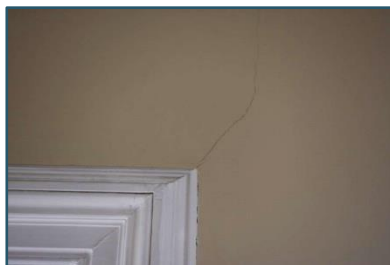
Figure 44: Diagonal crack at doorway to sitting room

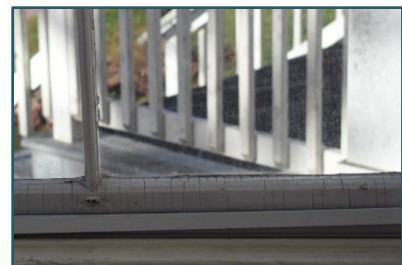
- C. The interior window paint was typically failing (Figure 45).
- D. One of glass screens in the sitting room bay windows was not properly installed (Figure 46).

Figure 45: Failing window paint

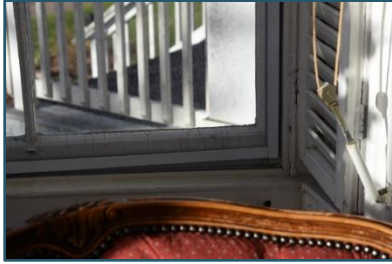
*Figure 46: Glass window screen improperly installed*

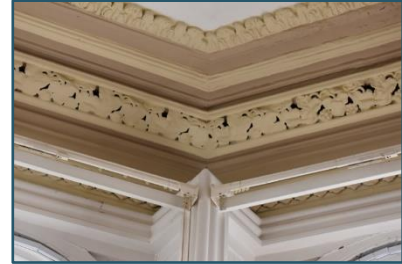
- E. The portion of ceiling underneath the lower roof was damaged from moisture accumulation. The decorative cornices had been rebuilt in recent years (Figure 47 and Figure 48).

*Figure 48: Change in detail where cornice was damaged*

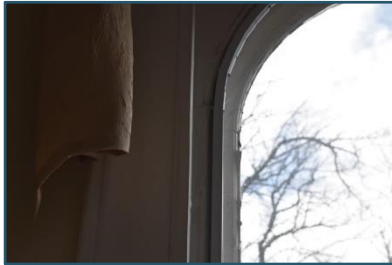
- F. Windows were typically poorly sealed from the interior (Figure 49).
- G. A corner cornice detail in the main room was cracked (Figure 50).
- H. There was a large gap at the joint between the westmost mantel and the wall in the main room (Figure 51).

*Figure 49: Poor seal around window in sitting room*

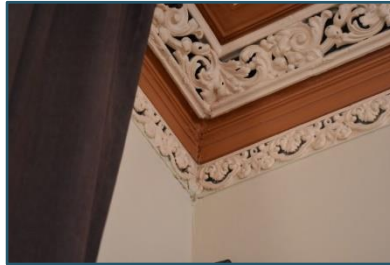
*Figure 50: Crack in corner cornice detail*

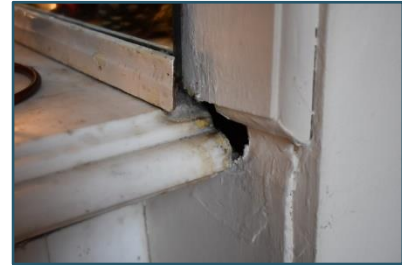
*Figure 51: Gap between chimney mantel and wall*

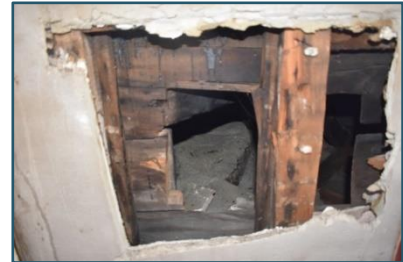
Figure 54: Opening into wall

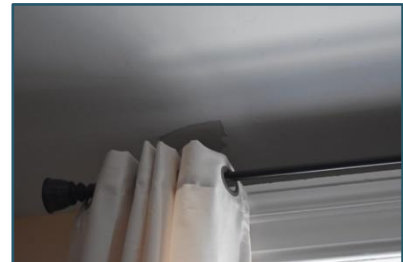
- K.** In the sitting room on the northern end of the second floor, the front façade windows were cracking (Figure 56). The paint had failed on a portion of the ceiling above the windows (Figure 57).

Figure 57: Failed paint on ceiling

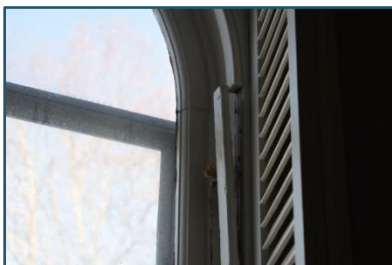
- L.** A piece of the wooden window frame in the dressing room was detached (Figure 58).
- M.** The floor in the Captain Nicola Goddard room was not level throughout the room. A small part of the floor towards the fireplace was broken (Figure 59). The frame around the northmost window was not flush to the window unit in some places, causing openings that encourage air infiltration (Figure 60).

Figure 58: Detached framing piece

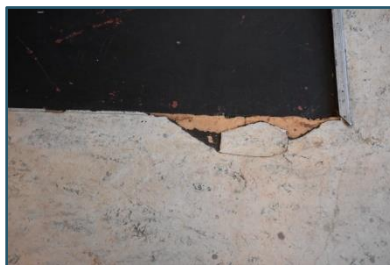
Figure 59: Broken floor

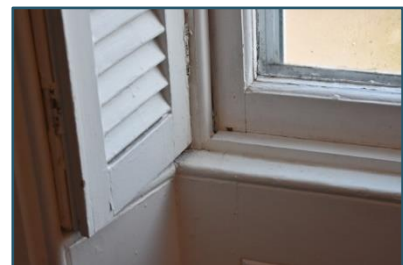
Figure 60: Poor seal

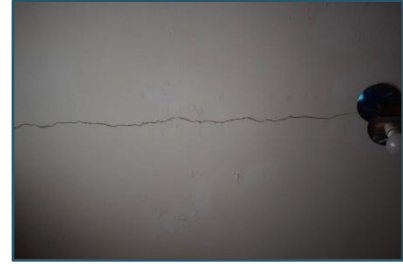
- P. The storage area south of the attic stairs had a large horizontal crack in the ceiling that spanned the entire length (Figure 63). There was some staining that indicated moisture was entering through the crack (Figure 64). The window paint on the window was failing (Figure 65).
- Q. Plaster cracking was typical throughout the second floor and varied in age and severity (Figure 66, Figure 67, Figure 68, Figure 69, Figure 70, Figure 71, and Figure 72). Some of the plaster cracking towards the small storage area south of the bathrooms looked recent, while other areas like the cracking in the Esther Full Lowden room appeared older as it was painted over.
- R. The walls typically tilted 1.2 degrees inwards. The tilt carried down to the first floor.

*Figure 63: Horizontal crack in ceiling*

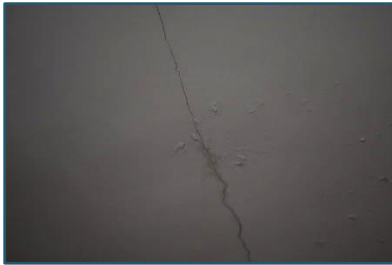
*Figure 64: Staining around crack in ceiling*

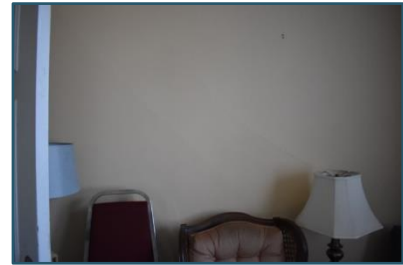
*Figure 66: Cracking in northwest room*

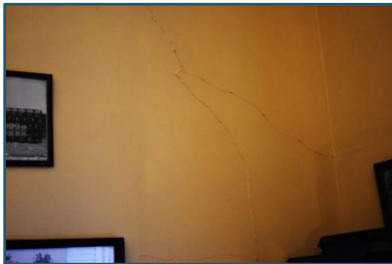
*Figure 67: Plaster cracking in Club Manager's Office*

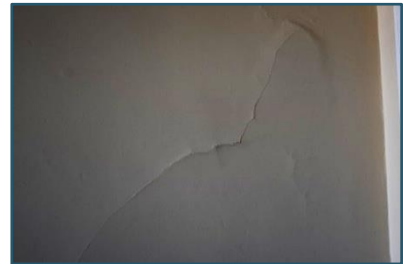
*Figure 69: Plaster cracking in dressing room*

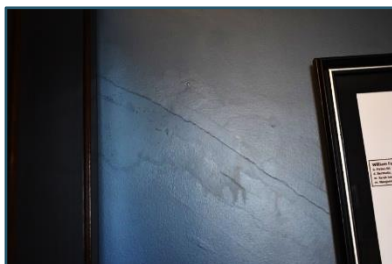
*Figure 70: Plaster cracking in Captain's room*

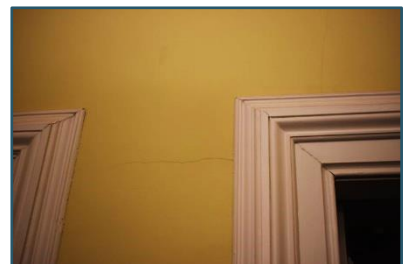
*Figure 72: Horizontal cracking in hallway*

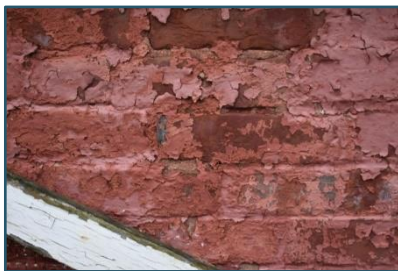
- A. The foundation was composed of brick and stone masonry. The foundation from the exterior was painted red with what appeared to be latex paint. The paint was failing throughout the foundation (Figure 73).

Figure 73: Failed paint

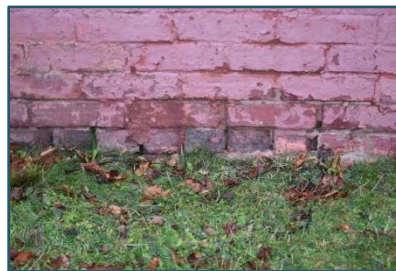
- B. About 10% of the foundation joints were open or washed out, but this was difficult to confirm due to the paint (Figure 74 and Figure 75).
- C. Deterioration of the lower courses of brick and stone was common. The condition was the worst on the east and south facades (Figure 76 and Figure 77).

Figure 74: Open joints in brick at base of wall on south facade

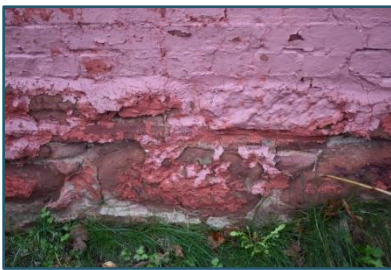
Figure 76: Deteriorating stone on east facade

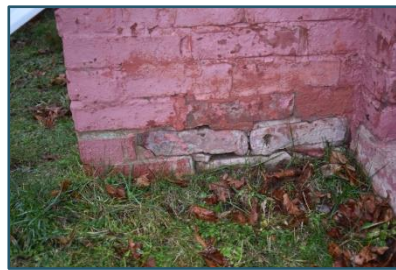
Figure 77: Deteriorating stone on south facade

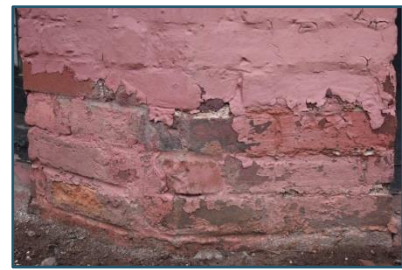
- D. Different types of bricks and mortar had been used for repairs in the past (Figure 78). It was difficult to determine the extent of past repairs due to the painted foundation.

Figure 78: Repair brick and mortar visible

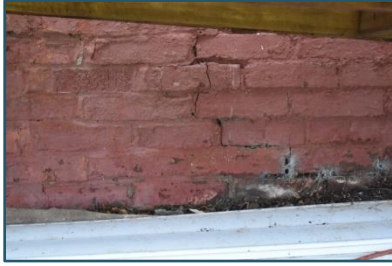
- E. The northeast and southeast corners had large vertical cracks that traveled through brick and mortar (Figure 79, Figure 80, Figure 81, and Figure 82).

*Figure 79: Cracking in east foundation*

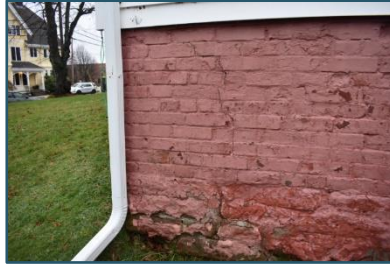
*Figure 80: Cracking in foundation at southeast corner*

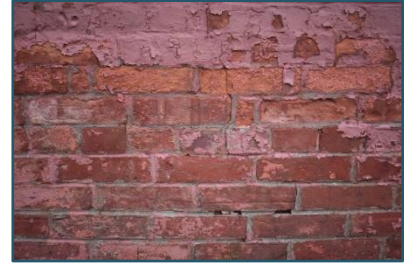
*Figure 81: Cracking in foundation on south facade*

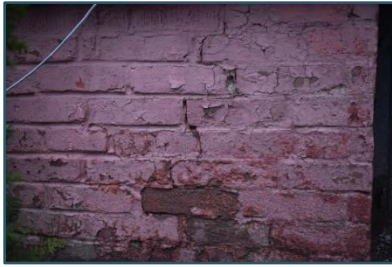
*Figure 82: Cracking in foundation at southwest corner*

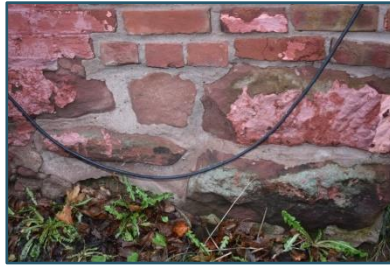
- F. Repair mortar on the east façade was applied very thick (Figure 83).
- G. The glass in a window well on the north foundation was broken (Figure 84).

*Figure 83: Thick joints in repair mortar*

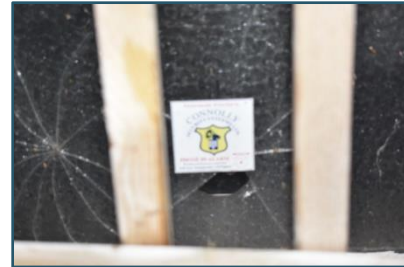
*Figure 84: Broken window well*

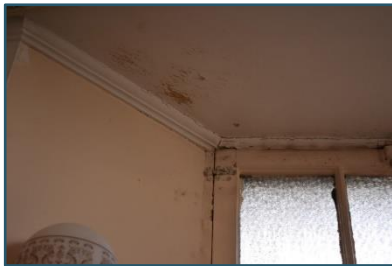
- H.** The moisture levels in the areas surrounding the front façade window wells were high (Figure 85).
- I.** A portion of wall was opened on the front façade (Figure 86). The opening showed stone and brick masonry that had been painted over and had concrete underpinning (Figure 87). The concrete underpinning would not be original. The foundation showed symptoms of high moisture in the past.

*Figure 85: High moisture content around front facade window wells*

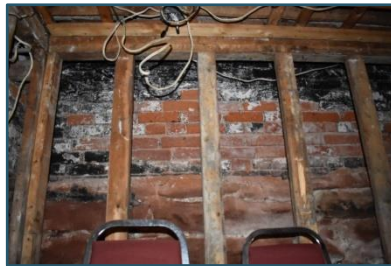
*Figure 86: Revealed foundation at front facade*

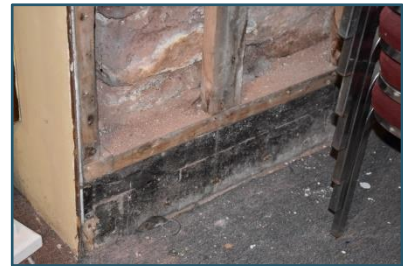
*Figure 87: Concrete underpinning on front facade foundation*

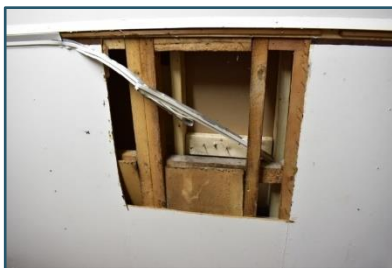
- J.** There was an opening in the wall in the large room towards the south façade (Figure 88 and Figure 89).
- K.** A portion of the foundation in the storage room towards the north façade was newly poured concrete (Figure 90). Building managers explained this was originally intended to be a separate entrance into the basement from the exterior. Another portion of foundation in this room was painted brick and stone (Figure 91). The masonry appeared to have had a lime wash applied in the past that was since painted over. The masonry had evidence of moisture accumulation and it is suspected that the paint is trapping moisture against the foundation (Figure 92). Some of the ceiling framing had moisture staining (Figure 93).

*Figure 88: Opening in wall in large southern room*

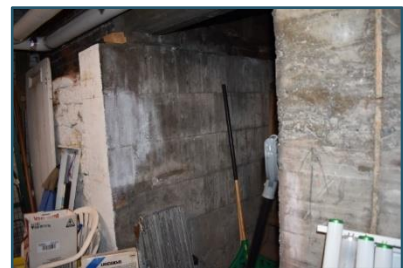
*Figure 90: New concrete foundation*

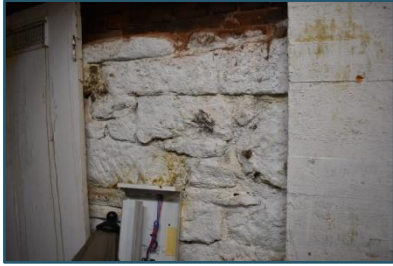
*Figure 91: Painted masonry foundation*

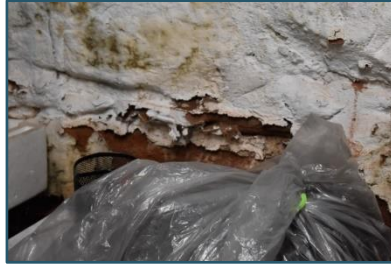
*Figure 92: Failing paint from high moisture content in walls*

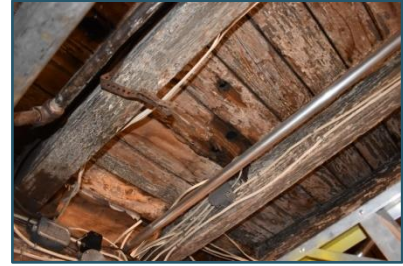
*Figure 93: Moisture staining in ceiling framing*

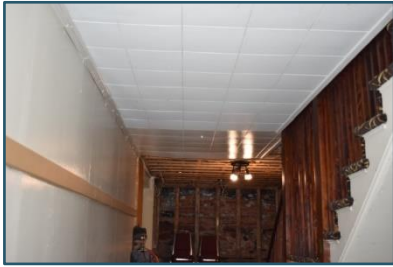
- L.** The ceiling tiles were deflecting (Figure 94). A portion of the ceiling framing was revealed towards the front façade (Figure 95).
- M.** The foundation towards the east façade did not appear to have any underpinning. The ground appeared to be lowered and a concrete slab was poured (Figure 96 and Figure 97).

*Figure 94: Deflecting ceiling tiles*

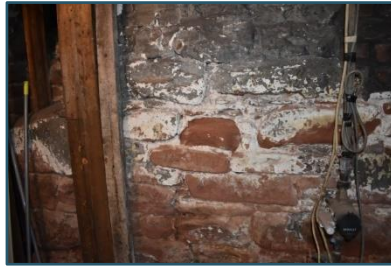
- N. The brick and stone masonry in the eastern foundation was in fair to poor condition (Figure 98). About 10% of the brickwork had deteriorated, with crumbling bricks and open mortar joints being common conditions (Figure 99). There was evidence of rising damp in the masonry, likely due to the concrete slab that absorbs moisture and transfers it up through the surrounding masonry.

*Figure 98: Damaged foundation masonry*

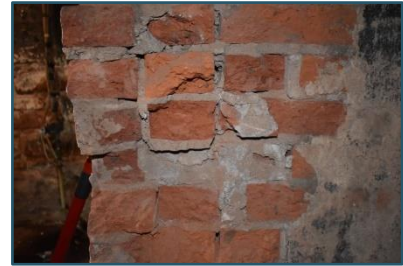
*Figure 99: Deteriorated brick*

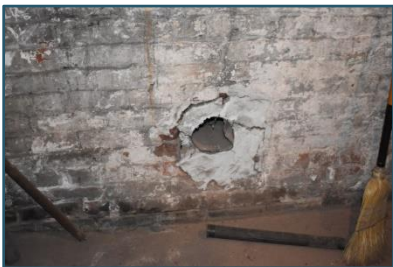
- O. Stone was deteriorating around a utility opening in the eastern foundation (Figure 100).
- P. A pipe was leaking onto the concrete slab below in the eastern foundation (Figure 101). Areas surrounding the pipe had high moisture content.

*Figure 100: Masonry damaged around utility opening*

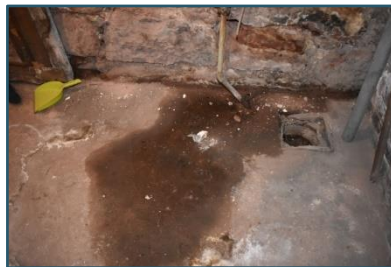
*Figure 101: Moisture around leaking pipe*

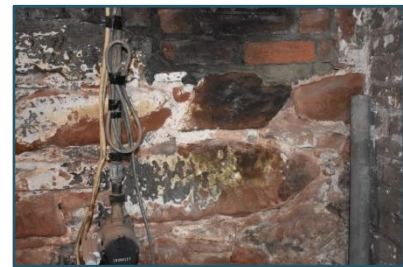
- Q. The eastern foundation masonry appeared to have had a lime wash applied in the past and had since been painted over (Figure 102). The paint likely was trapping moisture in the wall.

*Figure 102: Failing paint on masonry*

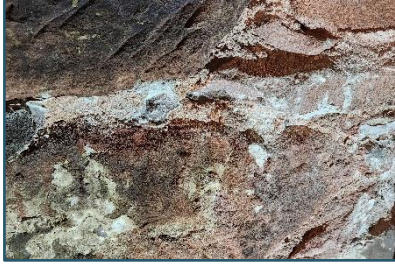
- R. Repair mortar in the eastern foundation had been applied in some locations but did not appear to be properly bonded to the masonry. A piece of mortar was easily removed, and it revealed sound historic mortar underneath (Figure 103).

*Figure 103: Mortar removed to reveal strong historic mortar underneath*

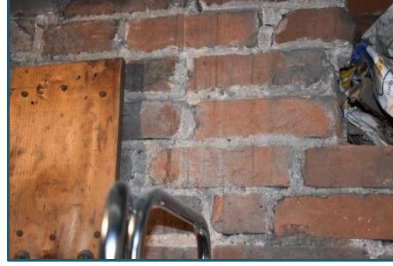
- S. Mortar was typically failing in the eastern foundation (Figure 104).
- T. The foundation at the southeast corner had parging applied overtop of the masonry (Figure 105).

*Figure 104: Failing mortar*

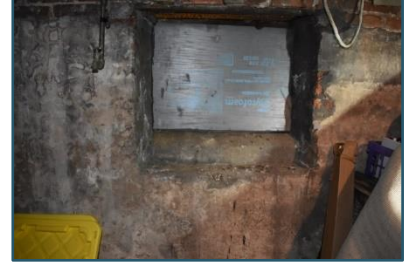
*Figure 105: Parging over masonry*

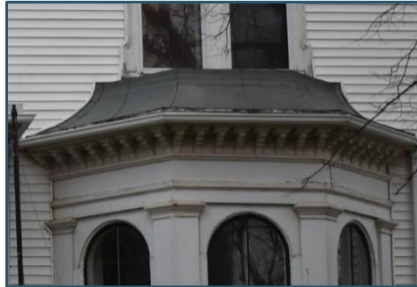
The roofs over the bay windows on the front façade do not have adequate slope on the flat portion to drain water (Figure 106, Figure 107, and Figure 108). This would have contributed to the past damage as it creates a more vulnerable design detail. This slope should be increased in the future to achieved better drainage without impacting the visual aesthetic of the building.

*Figure 106: Roof over southmost bay window on front facade*

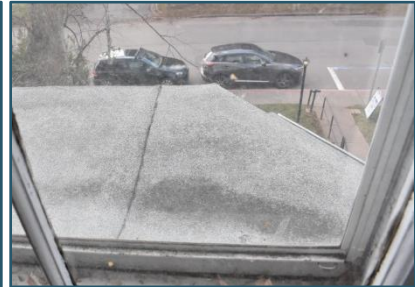
*Figure 108: Roof staining indicating an area prone to water accumulation*

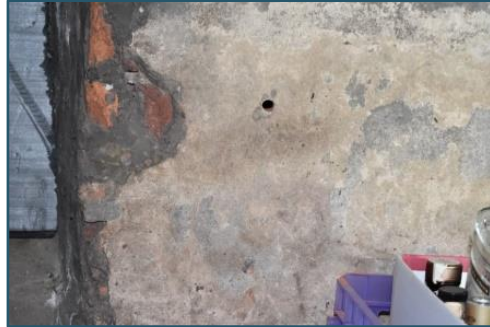
Figure 110: Borescope opening 2

A second hole was drilled in the southeast foundation about 1.2-1.3 m from the floor (Figure 110). The drill was inserted into the parging. The drilling varied from soft to hard. Borescope investigation found:

- The parge was very hard to drill through. It is suspected initial drilling was through brick.
- There was a larger void about 100 mm into the hole.
- Afterwards the drilling became softer with no significant voids encountered, and the hole was solid older mortar.
- A lot of dust came out of the hole while drilling which suggests there are less voids in the wall here.

Findings of the borescope investigation indicated that in areas with greater deterioration of the masonry it should be assumed that there are greater wall voids. The worst of these appeared in areas that past interventions did not use compatible materials or techniques, such as around the hard concrete parge.

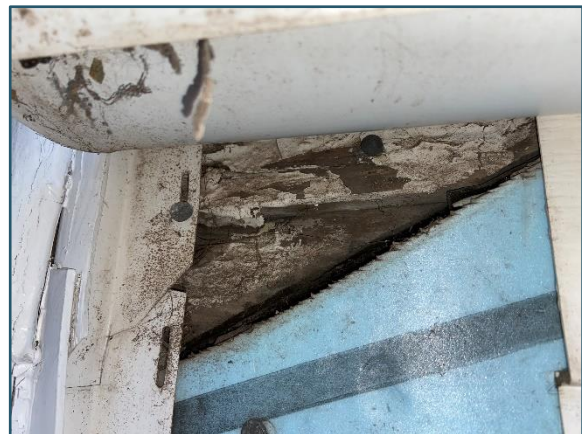
Based upon the visual inspection, the current vinyl siding was installed over existing damaged wood clapboard, with a thin layer of insulation added in between (Figure 111). The vinyl siding has been detailed to try to preserve the character and unique architectural features of the building.

Figure 111: Wood siding under vinyl, photo provided by Greg Munn 2022-12-21

While it appears that the vinyl siding has provided a weather resistant barrier to the building envelope since it was installed, our concerns are that there are a number of vulnerabilities in its design and installation that may become sources of damage in the future. The detailing of the siding requires many joints and junctions that create weak points, as the vinyl becomes more brittle overtime from the UV exposure. The application of vinyl siding for a historic building like Haviland Club is typically discouraged as it changes the traditional moisture mitigation details and is more likely to rely on products like silicone caulking, which have limited lifespans.

If Haviland Club proceeds with restoring the wood siding on the building, HSI recommends using a traditional linseed oil paint. A linseed oil would also be appropriate for any exterior wooden architectural elements.

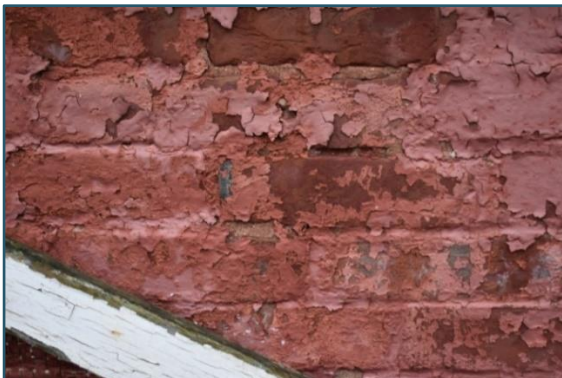
*Figure 112: Incompatible paint on brick*

For exterior foundation walls limewash is occasionally done but has a much shorter life span than interior application. Typically, the exterior masonry is left exposed, but if coatings are required use of either a coating designed for historic brick masonry, or mineral paints are initial considerations. Selection of the coating should be done by a professional.

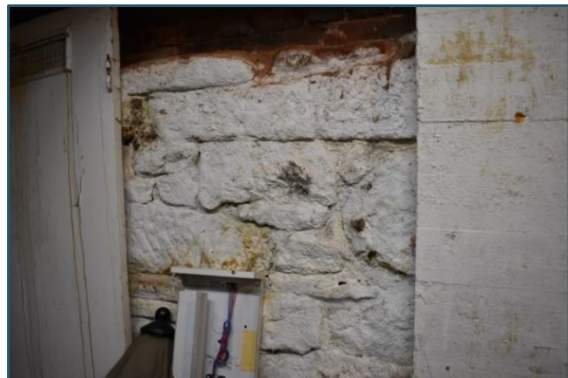
*Figure 113: Incompatible paint on interior foundation masonry*

For interior foundation walls a traditional approach is to use a hot lime wash. This lime wash, also referred to as white washing, provides a white coating that will help brighten the wall and water absorption properties that help control moisture in the wall. Done properly it should be relatively stable and should not flake off. Loss will occur in high moisture areas, but reapplication can be easily done.
