# Farringford House Haviland Club Membership Presentation Conservation/ Master Plan

2023.05.31

**HERITAGE STANDING INC.**

**MUNN  
ARCHITECTURE  
INC.**

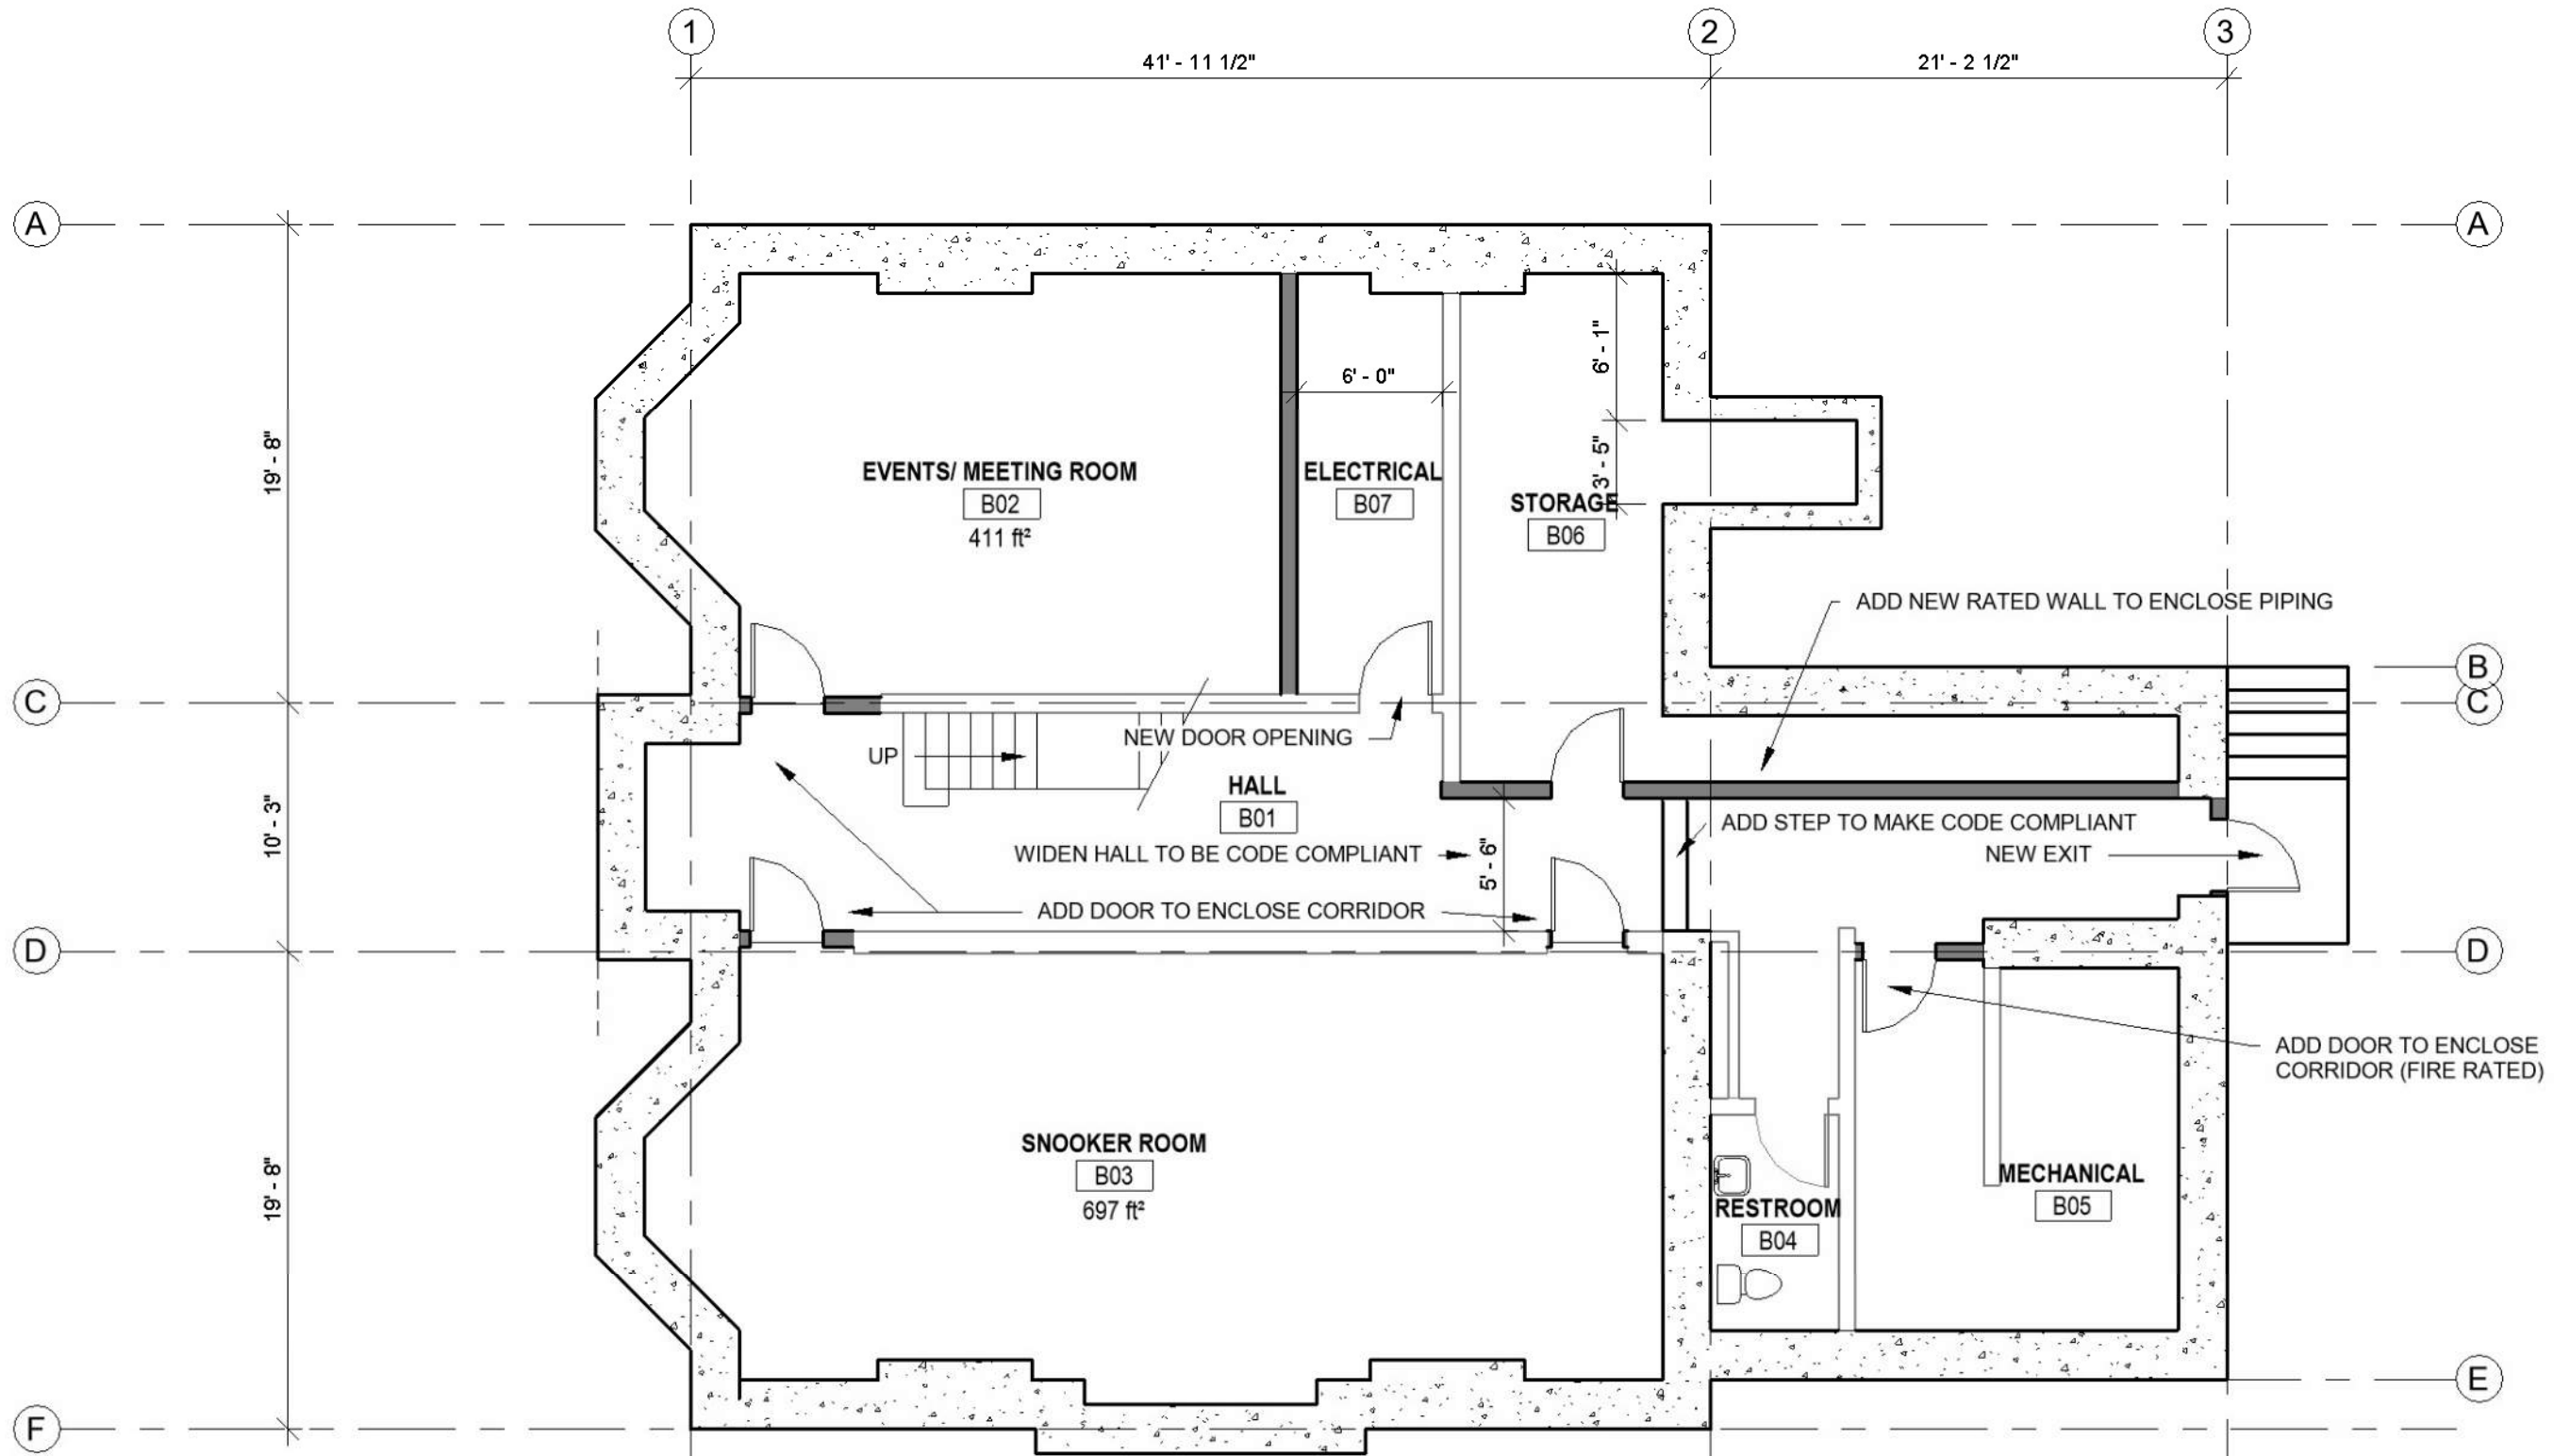
# BASEMENT LEVEL PROPOSED PLAN

Third Floor: If built, will require two exits  
Basement: needs 2 exits for assembly

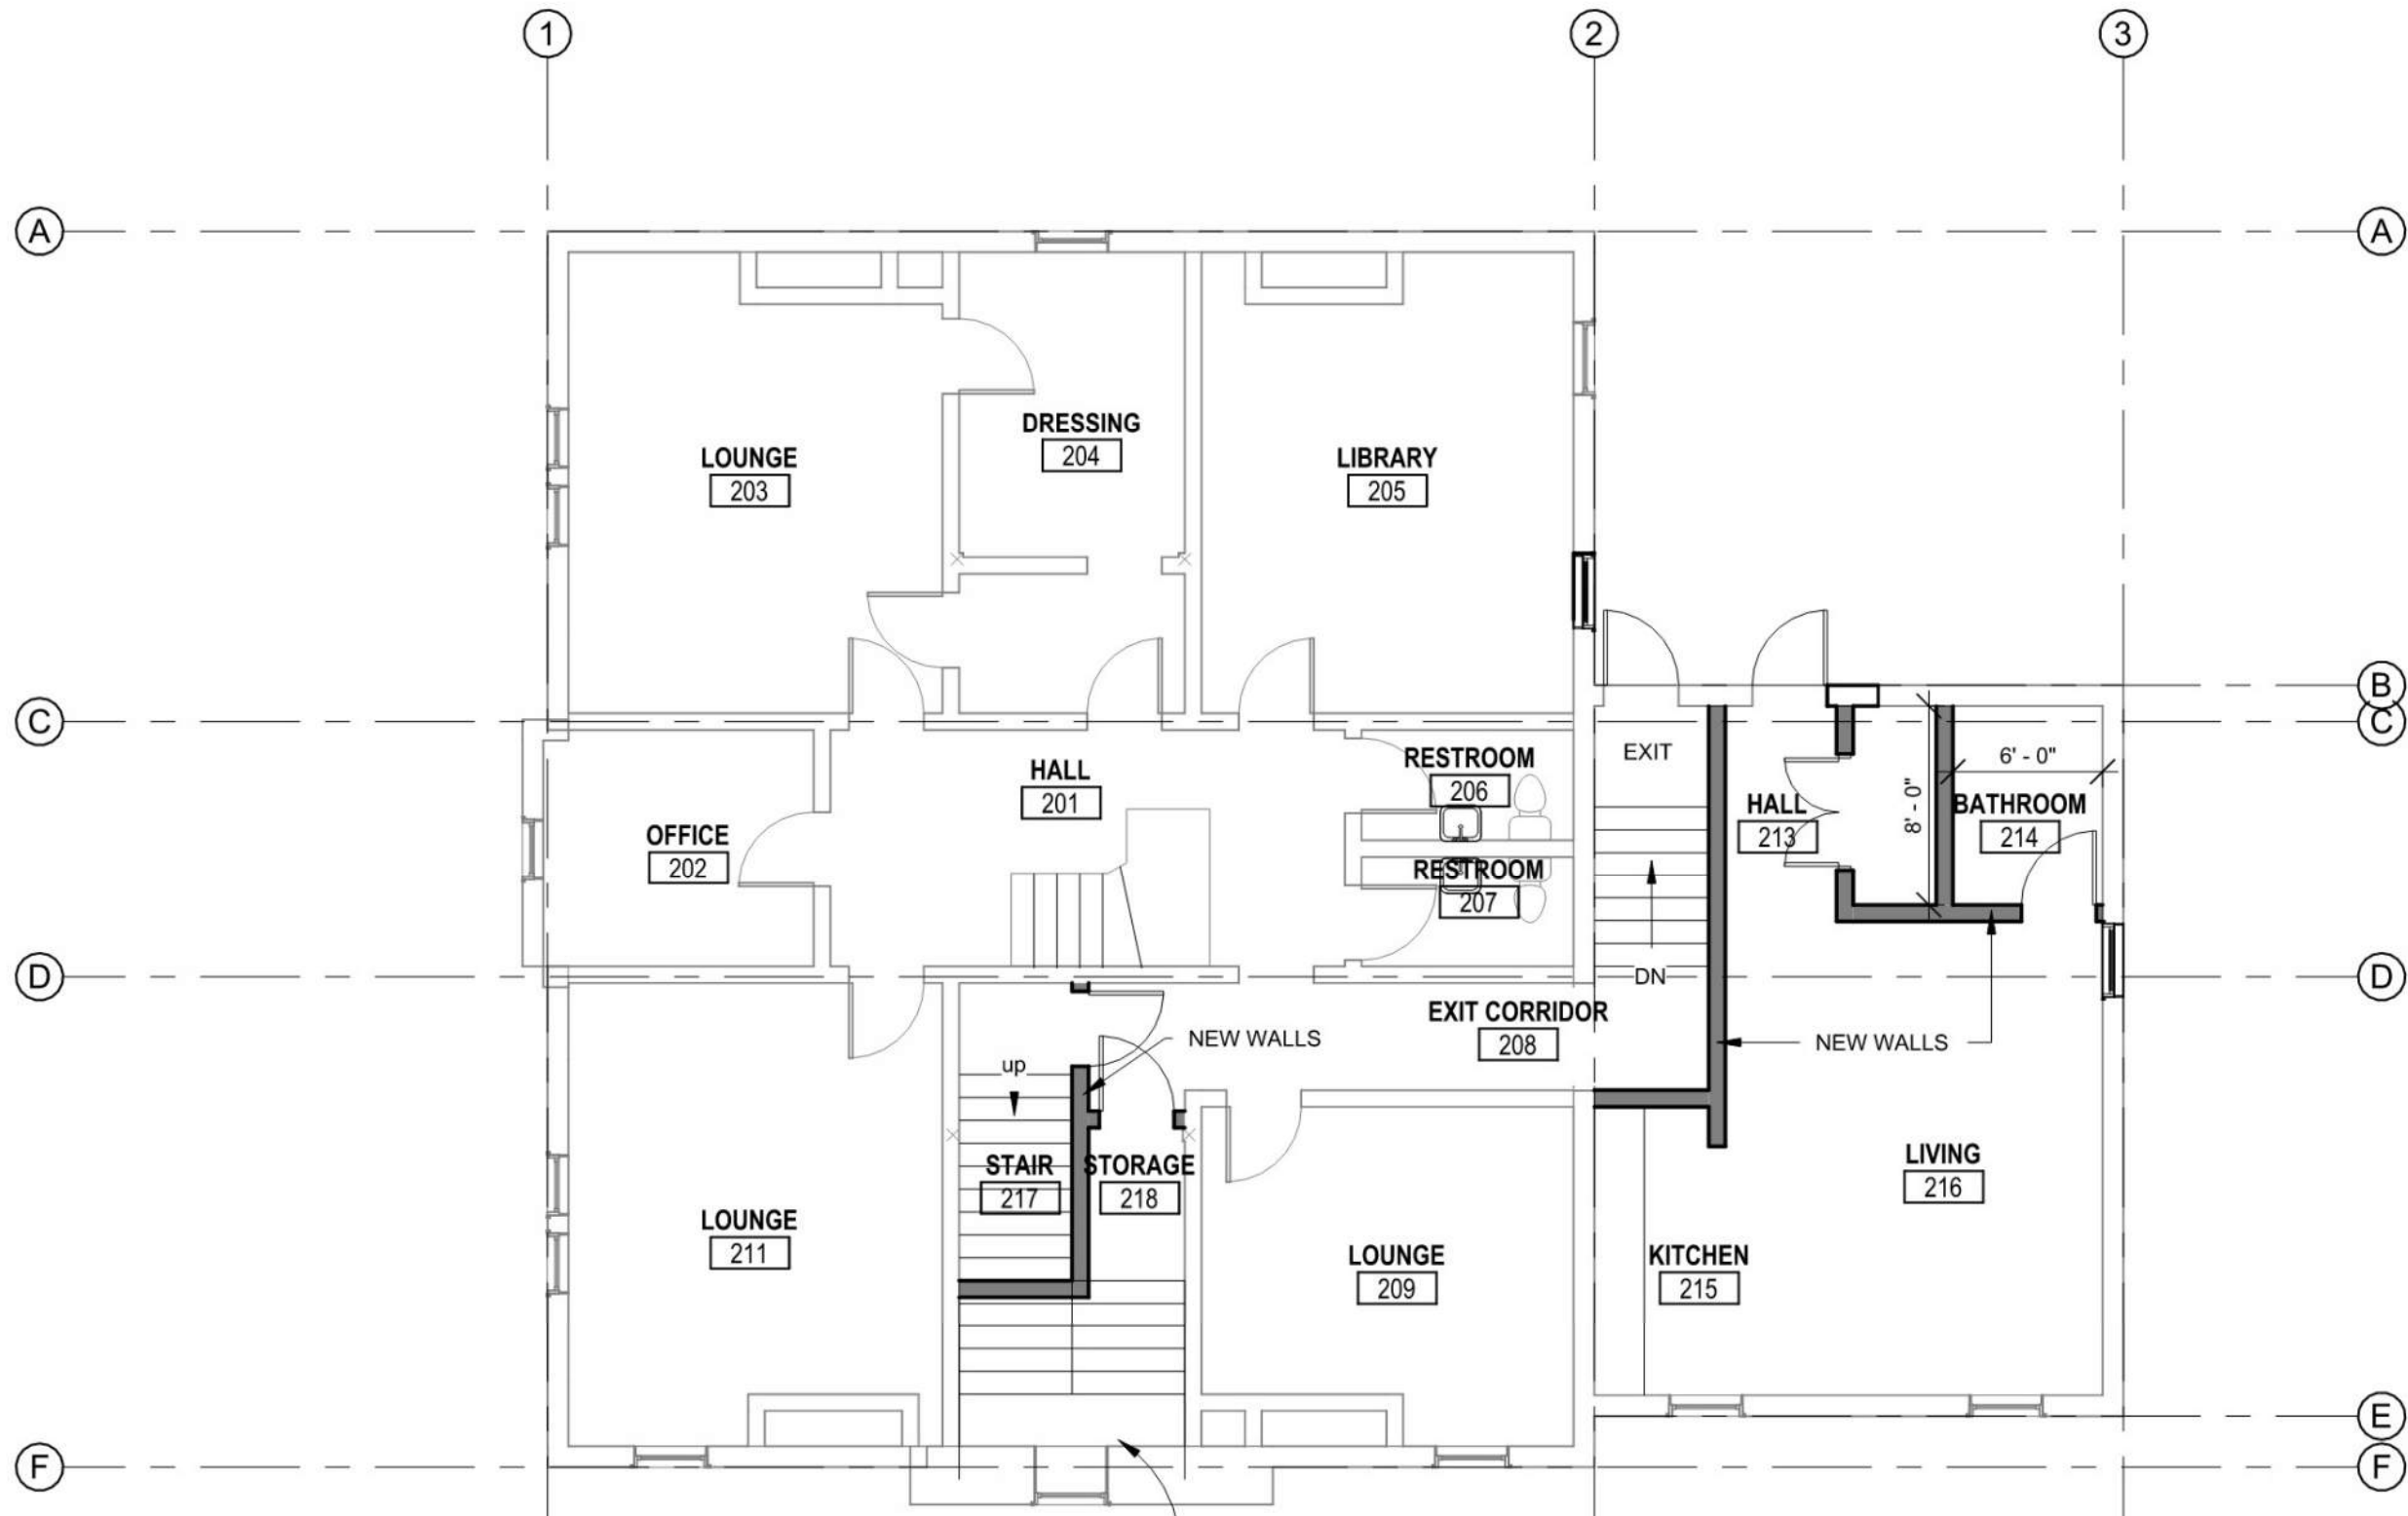
**SECOND FLOOR LEVEL  
PROPOSED PLAN**

21 RISERS  
REQUIRED

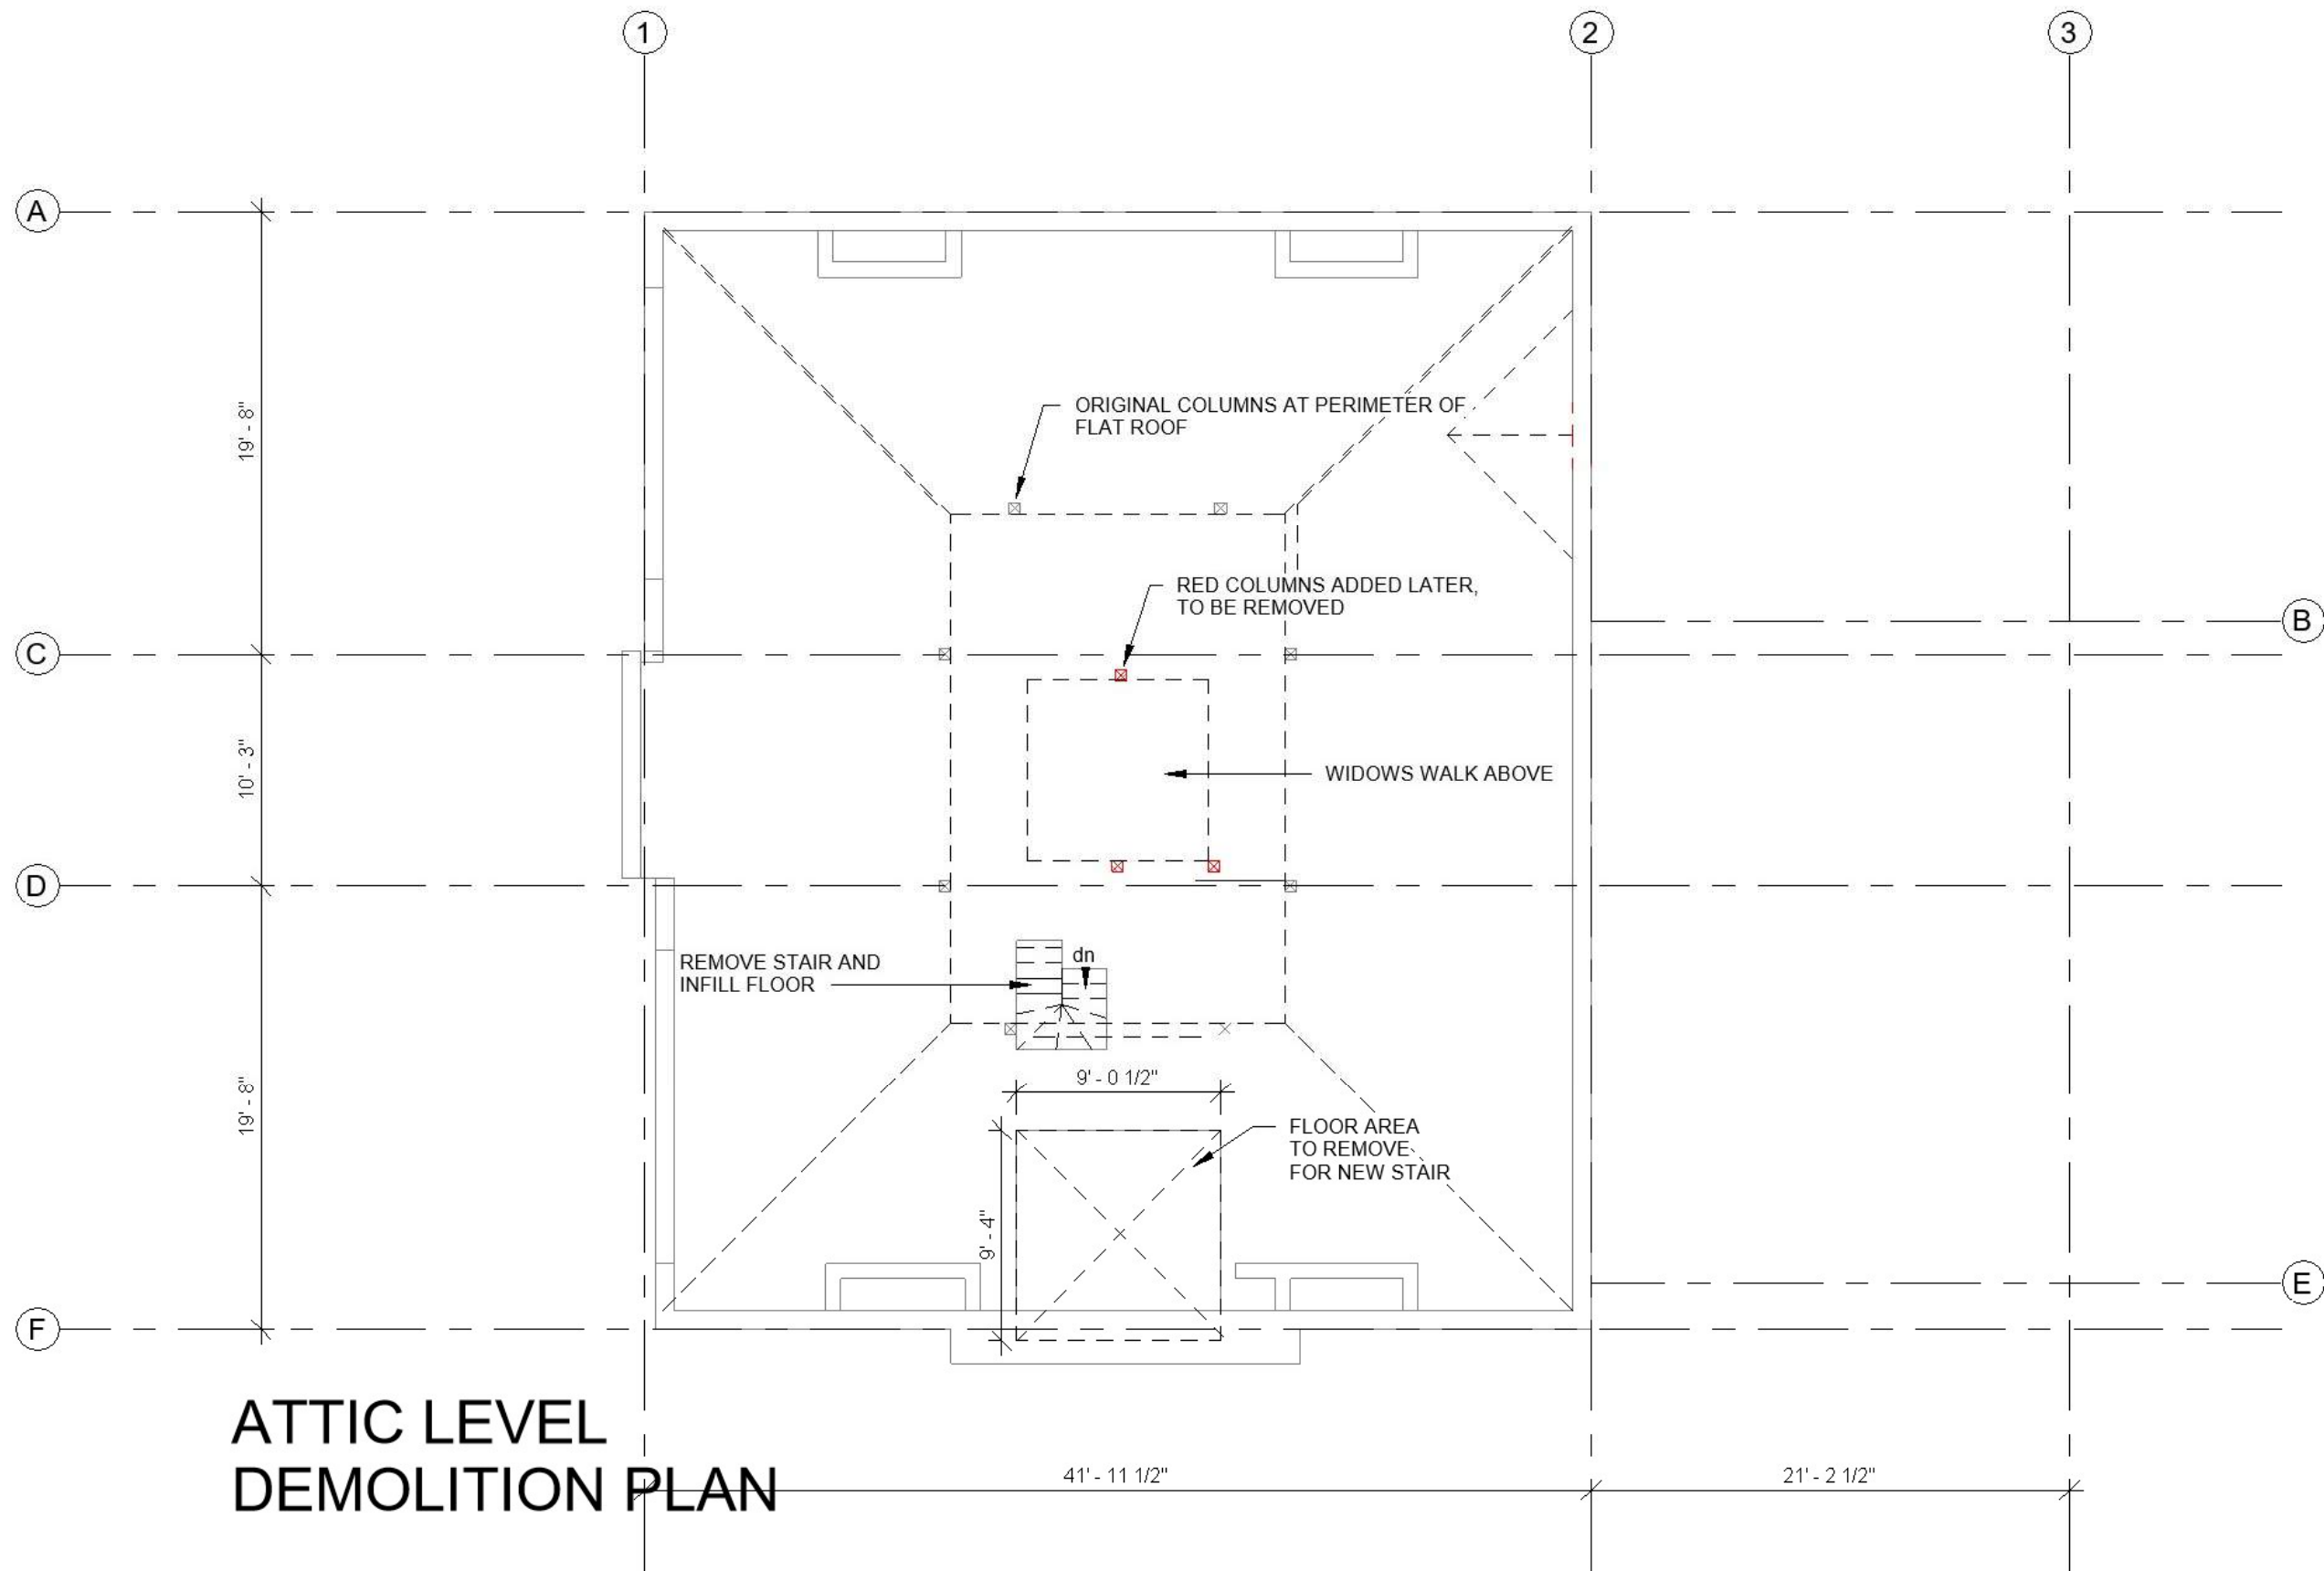
# ATTIC LEVEL DEMOLITION PLAN

**STRUCTURE (attic):** Structural failure in roof beams. Belvedere is not adequately supported.

HIGH PRIORITY  
roof structure  
flat roofs
