## HAVILAND CLUB ASSESSMENT

HSI Project No. 22359

Heritage Standing Inc. (HSI) was engaged by Greg Munn to conduct a conservation-based condition assessment of Haviland Club located on 2 Haviland St., PE. The building is undergoing a restoration and rehabilitation project and protecting the building's historic significance and architectural beauty is a priority.

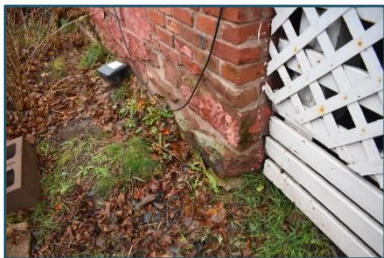
- A. The ground had a minor slope towards the building on a portion of the east façade (Figure 10). The landscaping was also growing directly adjacent to the building here.
- B. The ground beneath the downspout on the south façade was directing water towards the building (Figure 11).
- C. The front façade window wells were too close to the ground and surrounding landscaping, making them vulnerable to moisture infiltration (Figure 12).
- D. The paved walkway to the front entrance of the building was uneven (Figure 13).

*Figure 10: Ground immediately adjacent does not slope away from building*

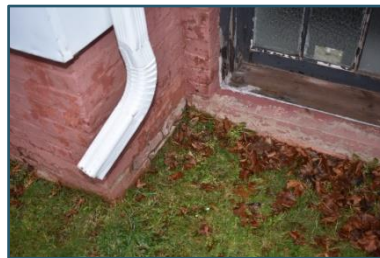
*Figure 11: Ground underneath downspout sunk around building*

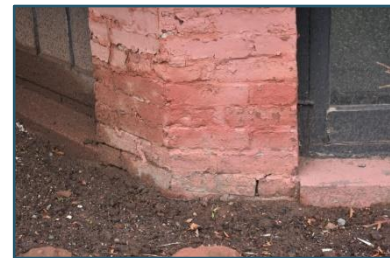
*Figure 12: Window wells set too close to ground*

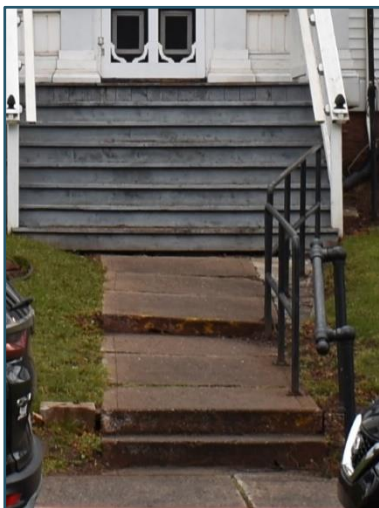
*Figure 13: Uneven walkway*

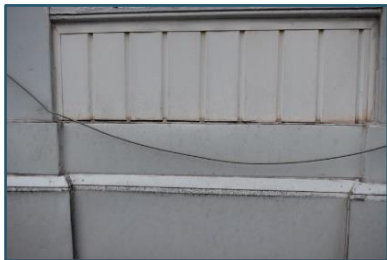
- A. The vinyl siding typically had poor details around joints and junctions; openings to the building envelope were common (Figure 14 and Figure 15).
- B. The exterior wood elements typically were coated in multiple layers of paint (Figure 16).

*Figure 14: Opening in junction between siding*

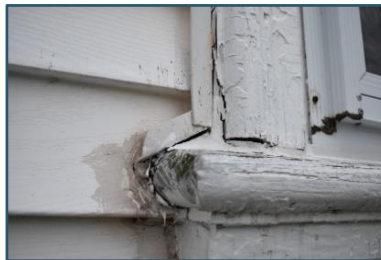
*Figure 15: Worn joint between siding and wooden windowsill*

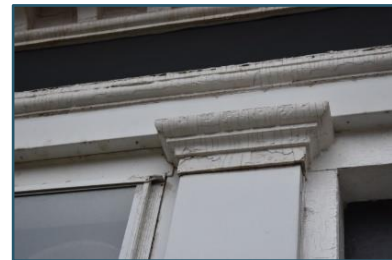
*Figure 16: Paint buildup*

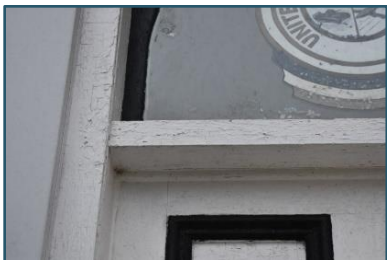
- C. Paint was typically crazing, cracking and failing on the wooden elements (Figure 17 and Figure 18). This is likely related to moisture being trapped in the wood by the paint.

*Figure 17: Crazing paint*

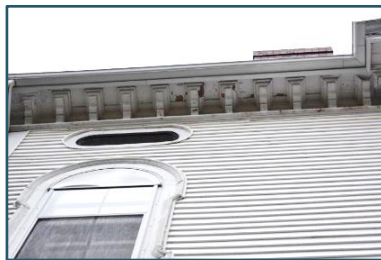
*Figure 18: Failed paint at the decorative brackets*

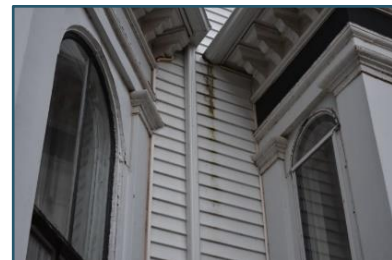
- D. The roof above the main entrance was directing moisture towards the siding and was causing moisture staining (Figure 19).
- E. The wooden windows were typically deteriorating, particularly between at the base of the frame and in the sashes (Figure 20 and Figure 21).

*Figure 19: Siding staining*

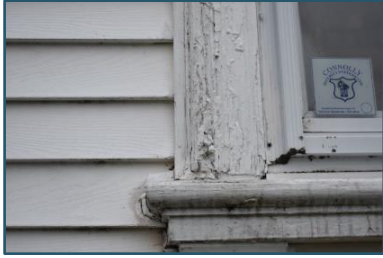
*Figure 20: Deterioration of wooden window frame*

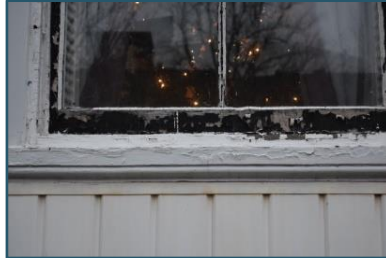
*Figure 21: Deteriorating window sash*

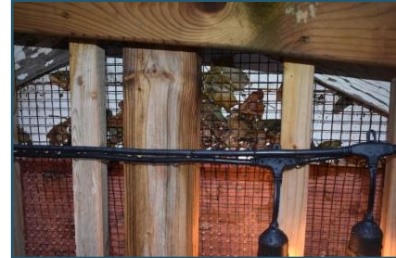
- F. The ramp railing on the north side of the building was trapping debris against the siding (Figure 22).
- G. The siding at the southwest corner had surface staining (Figure 23).

*Figure 22: Ramp railing trapped debris towards the building*

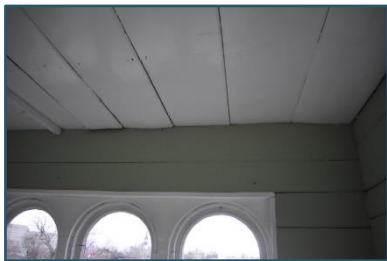
- A. The ceiling boards in the belvedere were uneven (Figure 25). One of the boards was broken (Figure 26).
- B. The belvedere windows had significant condensation (Figure 27). Moisture appeared to be infiltrating and was causing movement in the walls and ceiling boards.

Figure 25: Uneven ceiling boards in belvedere

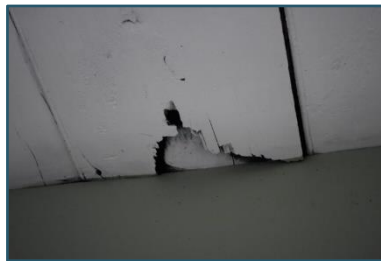
Figure 26: Broken ceiling board

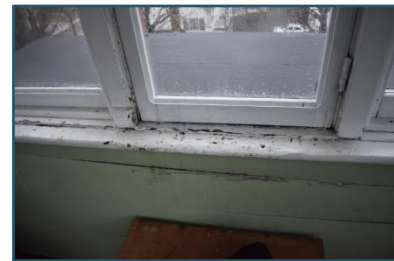
Figure 27: Condensation on windows and high moisture content in walls

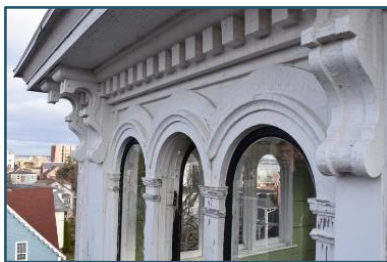
- C. Paint was typically failing on the exterior of the belvedere (Figure 28).
- D. The roof underneath the belvedere had varying slopes (Figure 29). The north and south slopes were under 1 degree which is typically seen as insufficient slope for drainage. It is suspected that moisture is not being adequately drained from the roof.

Figure 28: Failing paint

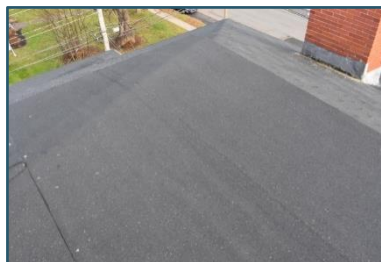
Figure 29: Low-sloped roof

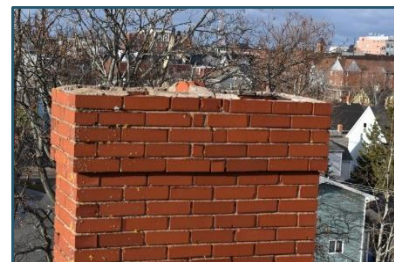
- E. The chimneys did not appear to be capped based upon initial drone investigation; discussions with the project architecture indicated that the chimneys are still in use, but this was not confirmed. The brick did not appear historic suggesting that the chimneys were rebuilt in recent years. The parging on top of the chimneys had failed and pieces were falling onto the roof below (Figure 30). The upper portion of the chimney brick masonry has deteriorated.

Figure 30: Failed parge

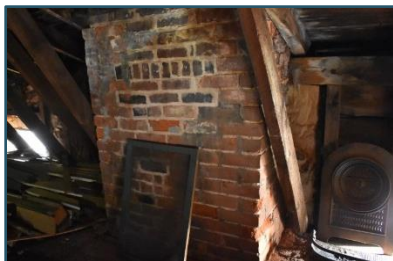
- F. The chimney masonry was in fair to poor condition where it could be viewed in the attic (Figure 31). Deterioration of various joints and potential incompatible past repairs was typical.

Figure 31: Chimney brick from attic

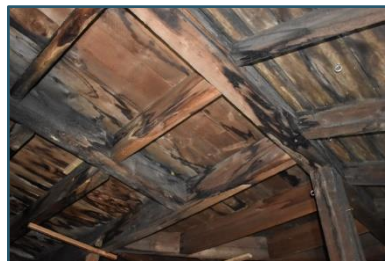
- G. The roof framing members had minor moisture staining (Figure 32).
- H. Three support posts were installed recently (Figure 33). The reason for their installation is unknown. They do not appear to transfer any load to the load bearing walls on the floor beneath.

Figure 32: Moisture staining

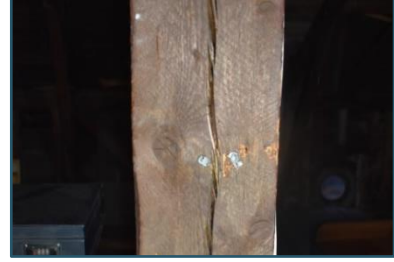
- I. Several structural wood members in the attic were significantly damaged. A major beam running parallel to the entrance into the belvedere had failed and requires urgent action (Figure 34). A major beam running perpendicular to the entrance into the belvedere was failing in torsion (Figure 35). Eight of the posts were splitting and the majority of these were the historic posts (Figure 36). Visual inspection looked for patterns to better understand the damages. Damages that occurred in the past will typically darken with age, so the colour of the openings in a wood member is an initial indication of when the problem may have occurred. Of the significantly damaged members, the cracking revealed bright new wood, which suggests there was recent change to the structure.

*Figure 36: Splitting post*

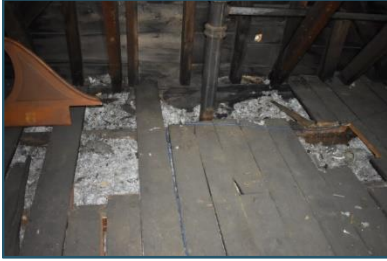
- J. The cellulose insulation seen in the attic, located above the second storey ceiling, appeared to have settled (Figure 37).
- K. The lower roof above the southmost bay window on the west façade has had a history of moisture issues (Figure 38). Upon visual inspection, the roof did not have an adequate slope to divert moisture away from the building (Figure 39). It is further suspected that there are open/worn joints between the roof and vinyl siding where moisture is infiltrating into the building.

*Figure 37: Settled insulation*

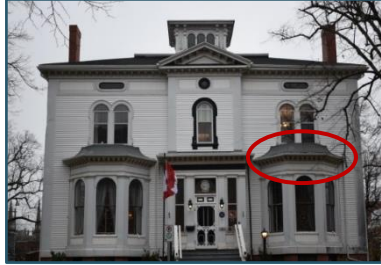
*Figure 38: Lower roof on southmost bay window circled in red, viewed from Haviland St.*

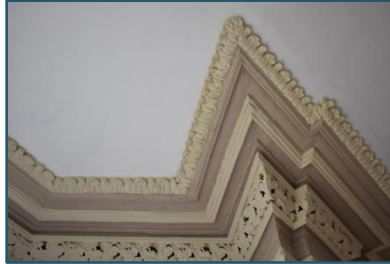
- E. The portion of ceiling underneath the lower roof was damaged from moisture accumulation. The decorative cornices had been rebuilt in recent years (Figure 47 and Figure 48).

*Figure 47: Damaged and repaired cornices*

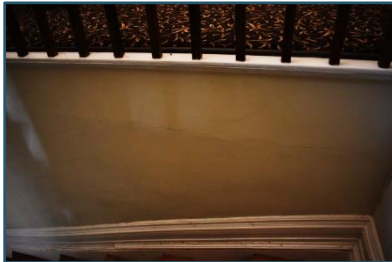
- I.** The plaster in the staircase up to the second floor was cracked (Figure 52).
- J.** The paint on the window shutters in the Esther Full Lowden room had failed (Figure 53) and the front façade window frame was cracking around the rounded arch (Figure 54). There was an opening into the wall that corresponded to the area with a history of moisture damage (Figure 55). There was evidence of moisture in the opening.

Figure 52: Plaster cracking in staircase

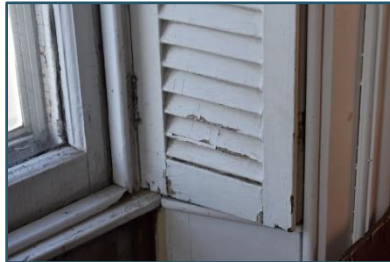
Figure 53: Failing paint on window shutters

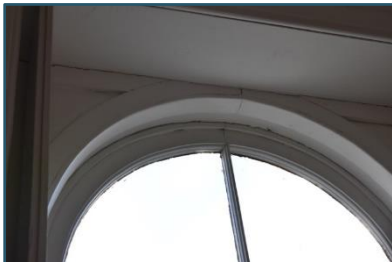
Figure 55: Cracking in window framing

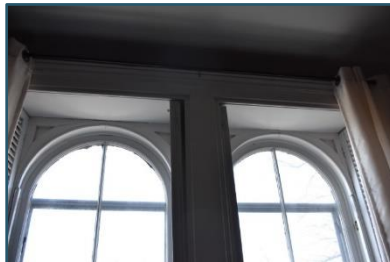
- K.** In the sitting room on the northern end of the second floor, the front façade windows were cracking (Figure 56). The paint had failed on a portion of the ceiling above the windows (Figure 57).

Figure 56: Cracking in window framing

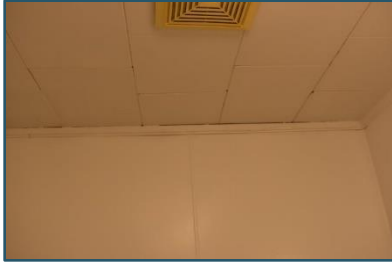
- N.** Both bathrooms on the second floor had poor seals at joints between the walls and ceilings as well as the walls and the baseboards (Figure 61).
- O.** A small portion of wood panelling pieces in the president meeting room were becoming detached (Figure 62).

*Figure 61: Poor seals at joint between walls and ceiling in bathrooms*

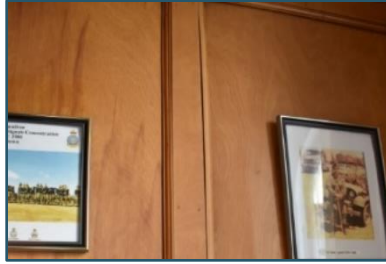
*Figure 62: Wood panelling becoming detached*

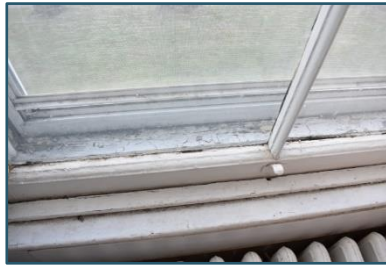
- P. The storage area south of the attic stairs had a large horizontal crack in the ceiling that spanned the entire length (Figure 63). There was some staining that indicated moisture was entering through the crack (Figure 64). The window paint on the window was failing (Figure 65).
- Q. Plaster cracking was typical throughout the second floor and varied in age and severity (Figure 66, Figure 67, Figure 68, Figure 69, Figure 70, Figure 71, and Figure 72). Some of the plaster cracking towards the small storage area south of the bathrooms looked recent, while other areas like the cracking in the Esther Full Lowden room appeared older as it was painted over.
- R. The walls typically tilted 1.2 degrees inwards. The tilt carried down to the first floor.

*Figure 65: Paint failing around window*

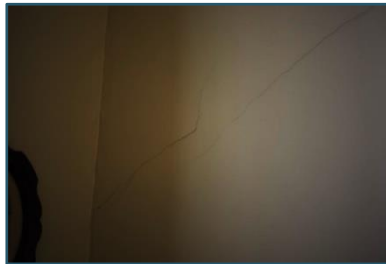
*Figure 68: Plaster cracking in dressing room*

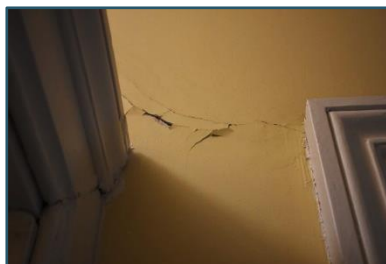
*Figure 71: Plaster cracking at storage area south of bathrooms*

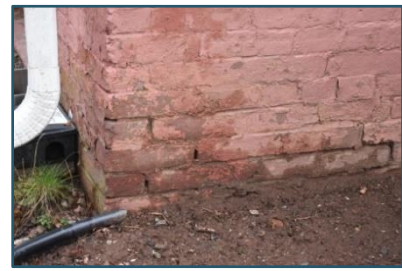
- B. About 10% of the foundation joints were open or washed out, but this was difficult to confirm due to the paint (Figure 74 and Figure 75).
- C. Deterioration of the lower courses of brick and stone was common. The condition was the worst on the east and south facades (Figure 76 and Figure 77).

Figure 75: Open joints in masonry on front facade

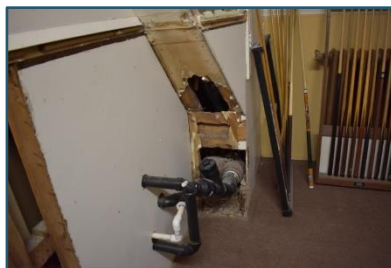
- J.** There was an opening in the wall in the large room towards the south façade (Figure 88 and Figure 89).
- K.** A portion of the foundation in the storage room towards the north façade was newly poured concrete (Figure 90). Building managers explained this was originally intended to be a separate entrance into the basement from the exterior. Another portion of foundation in this room was painted brick and stone (Figure 91). The masonry appeared to have had a lime wash applied in the past that was since painted over. The masonry had evidence of moisture accumulation and it is suspected that the paint is trapping moisture against the foundation (Figure 92). Some of the ceiling framing had moisture staining (Figure 93).

*Figure 89: Opening in wall in large southern room*

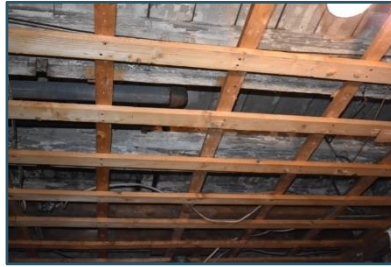
- L.** The ceiling tiles were deflecting (Figure 94). A portion of the ceiling framing was revealed towards the front façade (Figure 95).
- M.** The foundation towards the east façade did not appear to have any underpinning. The ground appeared to be lowered and a concrete slab was poured (Figure 96 and Figure 97).

*Figure 95: Revealed ceiling framing*

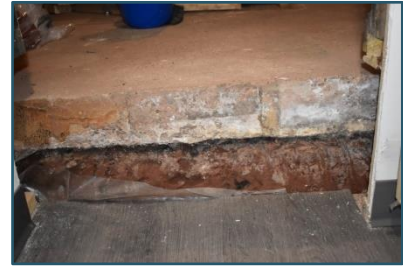
*Figure 96: Poured concrete slab*

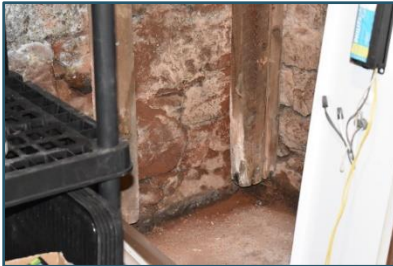
*Figure 97: Framing shows where ground was before being lowered*

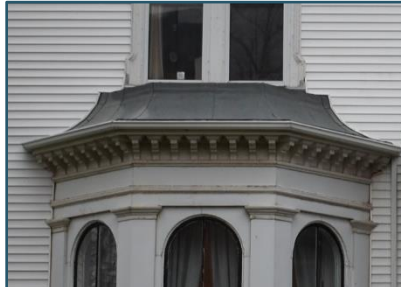
The roofs over the bay windows on the front façade do not have adequate slope on the flat portion to drain water (Figure 106, Figure 107, and Figure 108). This would have contributed to the past damage as it creates a more vulnerable design detail. This slope should be increased in the future to achieved better drainage without impacting the visual aesthetic of the building.

*Figure 107: Roof over northmost bay window on front facade*
